Flood Control Project Maintenance
2018 Structure Summary Report
Overall Unit and Item Ratings

San Joaquin County Flood Control and Water Conservation District

Flood Control Project Maintenance**Unit Cover Sheet****2018 Structure Inspection Results****San Joaquin County Flood Control and Water Conservation District**

Structure
Duck Creek Diversion Weir And Control Structure

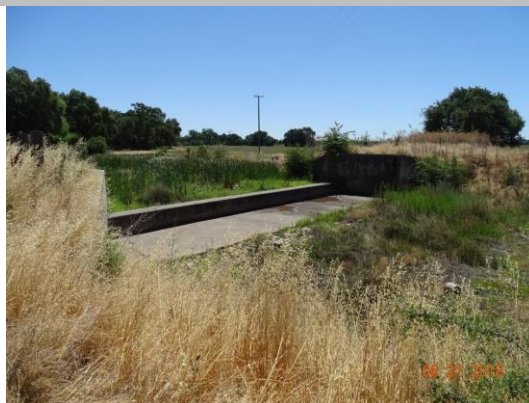
Photo 1 of 2 : ST_2018_NA0017_5_24_20180625_00019.jpg

LM Start	0.00	Rating **	N	Issue No.	24
LM End	0.00	Issue Type +	Ma	Location *	
Category	Structures & Concrete Lined Channels			GPS Latitude/Longitude	
				Start	End
Item	Photo Documentation			37.938383 °	37.938383 °
				-120.990133 °	-120.990133 °
DWR ID	DWR_NA0017_5_t_2013_24				
Action/Comments					
Inspector Comments: Duck Creek Diversion Structure works as a control weir for Duck Creek and also diverts the overflow of the channel to Duck Creek Diversion channel which connects with Little John Creek.

View of the weir. Summer 2018

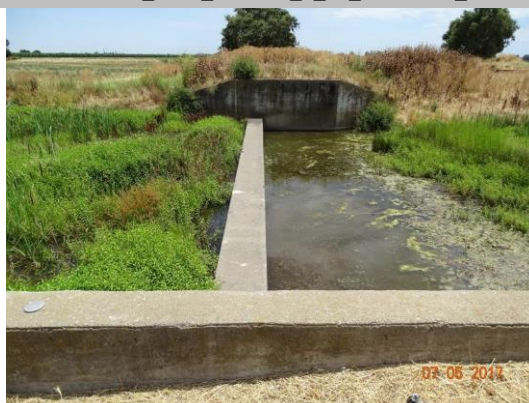
Photo 2 of 2 : ST_2018_NA0017_5_24_20180530_00012.jpg

View of the weir.

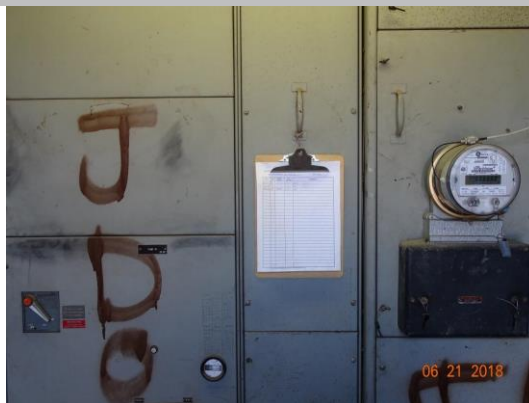
Photo 1 of 1 : ST_2018_NA0017_18_1_20180625_00020.jpg

LM Start	0.00	Rating **	A	Issue No.	1
LM End	0.00	Issue Type +	Ma	Location *	
Category	Pump Stations			GPS Latitude/Longitude	
				Start	End
Item	Operating Log			37.989633 °	37.989633 °
				-121.266933 °	-121.266933 °
DWR ID	DWR_NA0017_18_t_2012_1				
Action/Comments					
Inspector Comments: Operating log was maintained and present at the pumping plant.

View of the operation log in the plant.

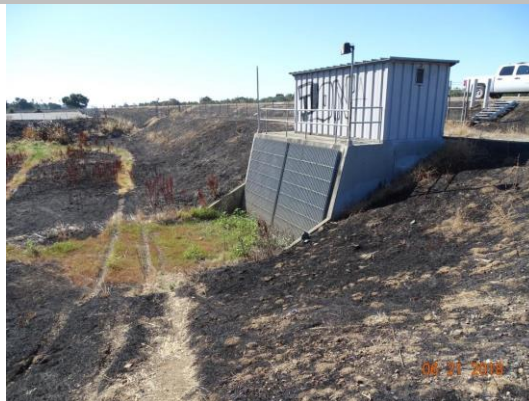
Photo 1 of 1 : ST_2018_NA0017_18_13_20180625_00023.jpg

LM Start	0.00	Rating **	A	Issue No.	13
LM End	0.00	Issue Type +	Ma	Location *	
Category	Pump Stations			GPS Latitude/Longitude	
				Start	End
Item	Trash Racks			37.989633 °	37.989633 °
				-121.266933 °	-121.266933 °
DWR ID	DWR_NA0017_18_t_2012_13				
Action/Comments					
Inspector Comments: Trash racks were properly maintained and clear of debris.

View of the trash racks.

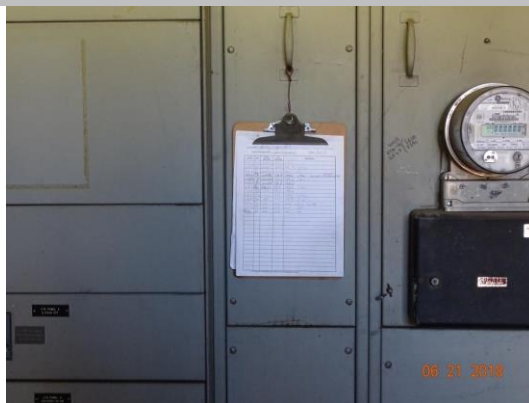
Photo 1 of 1 : ST_2018_NA0017_19_1_20180625_00015.jpg

LM Start	0.00	Rating **	A	Issue No.	1
LM End	0.00	Issue Type +	Ma	Location *	
Category	Pump Stations			GPS Latitude/Longitude	
				Start	End
Item	Operating Log			37.982317 °	37.982317 °
				-121.249433 °	-121.249433 °
DWR ID	DWR_NA0017_19_t_2012_1				
Action/Comments					
Inspector Comments: Operational log was present at the pump station.

View of the operation log inside the pumping plant.

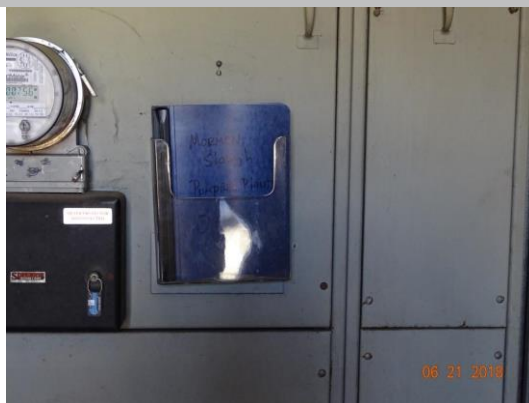
Photo 1 of 1 : ST_2018_NA0017_19_2_20180625_00016.jpg

LM Start	0.00	Rating **	A	Issue No.	2
LM End	0.00	Issue Type +	Ma	Location *	
Category	Pump Stations			GPS Latitude/Longitude	
				Start	End
Item	Operation & Maintenance Manual			37.982317 °	37.982317 °
				-121.249433 °	-121.249433 °
DWR ID	DWR_NA0017_19_t_2012_2				
Action/Comments					
Inspector Comments: O&M Manual was found inside the plant during the inspection.

View of the O&M manual inside the plant.

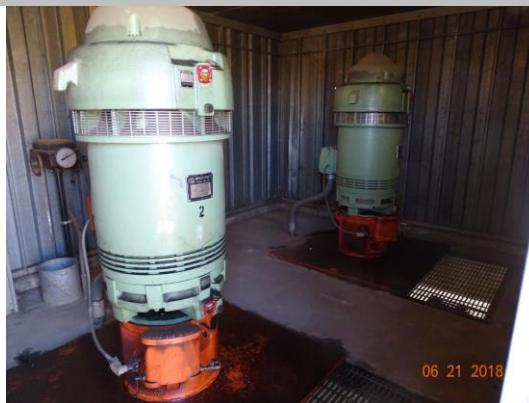
Photo 1 of 2 : ST_2018_NA0017_19_7_20180625_00019.jpg

LM Start	0.00	Rating **	A	Issue No.	7
LM End	0.00	Issue Type +	Ma	Location *	
Category	Pump Stations			GPS Latitude/Longitude	
				Start	End
Item	Pumps			37.982317 °	37.982317 °
				-121.249433 °	-121.249433 °
DWR ID	DWR_NA0017_19_t_2012_7				
Action/Comments					
Inspector Comments: The pumps appeared to be well maintained and lubricated properly and the pumping system was tested periodically.

View of the pumps inside the pumping plant.

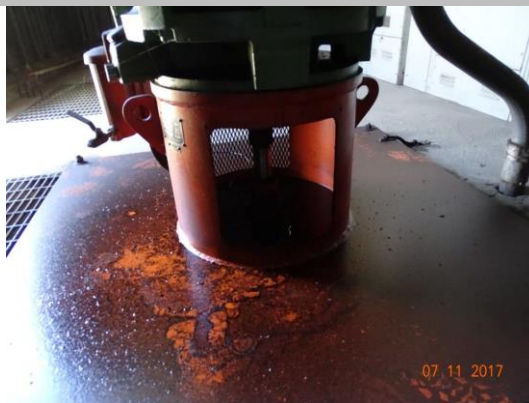
Photo 2 of 2 : ST_2018_NA0017_19_7_20180530_00007.jpg

View of the shaft under a pump.

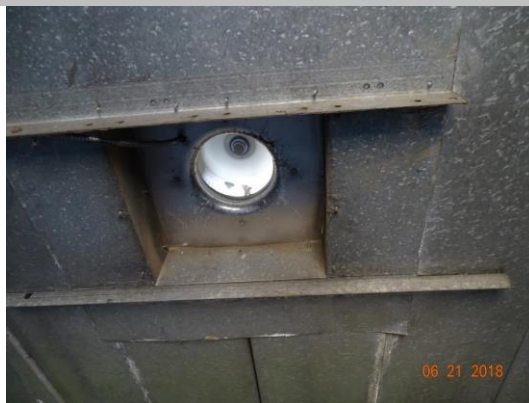
Photo 1 of 1 : ST_2018_NA0017_19_10_20180625_00022.jpg

LM Start	0.00	Rating **	A	Issue No.	10
LM End	0.00	Issue Type +	Ma	Location *	
Category	Pump Stations			GPS Latitude/Longitude	
				Start	End
Item	Motors, Engines, Fans & Gear Reducers			37.982317 °	37.982317 °
				-121.249433 °	-121.249433 °
DWR ID	DWR_NA0017_19_t_2012_10				
Action/Comments					
Inspector Comments: The vent fan was operational during the inspection.

View of the vent fan.

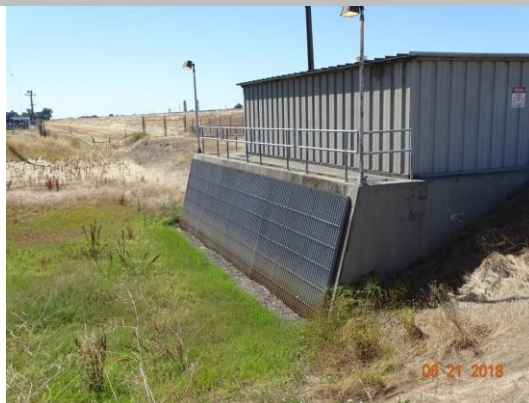
Photo 1 of 1 : ST_2018_NA0017_19_13_20180625_00024.jpg

LM Start	0.00	Rating **	A	Issue No.	13
LM End	0.00	Issue Type +	Ma	Location *	
Category	Pump Stations			GPS Latitude/Longitude	
				Start	End
Item	Trash Racks			37.982317 °	37.982317 °
				-121.249433 °	-121.249433 °
DWR ID	DWR_NA0017_19_t_2012_13				
Action/Comments					
Inspector Comments: Trash racks were properly maintained and free of any debris.

View of the trash racks.

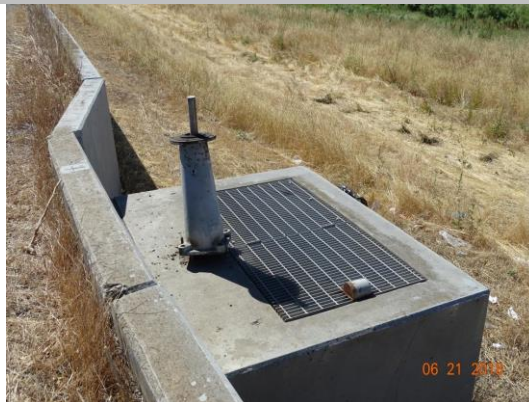
Photo 1 of 1 : ST_2018_NA0017_19_15_20180625_00025.jpg

LM Start	0.00	Rating **	M	Issue No.	15
LM End	0.00	Issue Type +	Ma	Location *	
Category	Pump Stations			GPS Latitude/Longitude	
				Start	End
Item	Sluice / Slide Gates			37.982317 °	37.982317 °
				-121.249433 °	-121.249433 °
DWR ID	DWR_NA0017_19_t_2012_15				
Action/Comments					
Inspector Comments: The slide gate is not currently operational and requires repair.

View of the slide gate.

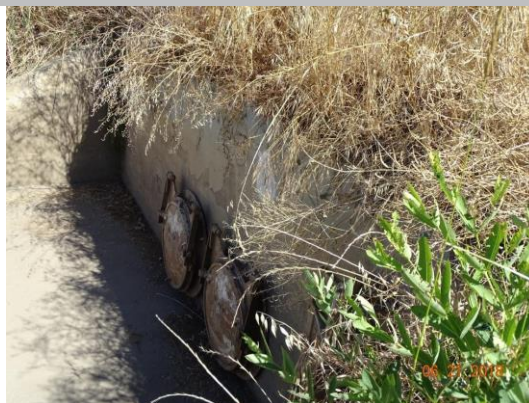
Photo 1 of 1 : ST_2018_NA0017_19_19_20180625_00026.jpg

LM Start	0.00	Rating **	A	Issue No.	19
LM End	0.00	Issue Type +	Ma	Location *	
Category	Pump Stations			GPS Latitude/Longitude	
				Start	End
Item	Flap Gates			37.982317 °	37.982317 °
				-121.249433 °	-121.249433 °
DWR ID	DWR_NA0017_19_t_2012_19				
Action/Comments					
Inspector Comments: Flap gates were in good condition and showed no damage. There was a lot of vegetation growth around the outlet, but the gates operation was not affected.

View of the flap gates for the pumping plant.

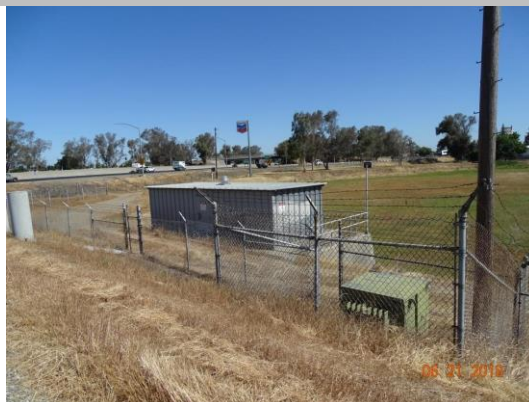
Photo 1 of 1 : ST_2018_NA0017_19_21_20180625_00027.jpg

LM Start	0.00	Rating **	A	Issue No.	21
LM End	0.00	Issue Type +	Ma	Location *	
Category	Pump Stations			GPS Latitude/Longitude	
				Start	End
Item	Security Fencing			37.982317 °	37.982317 °
				-121.249433 °	-121.249433 °
DWR ID	DWR_NA0017_19_t_2012_21				
Action/Comments					
Inspector Comments: Security fencing was in good condition without any damage.

View of the security fencing.

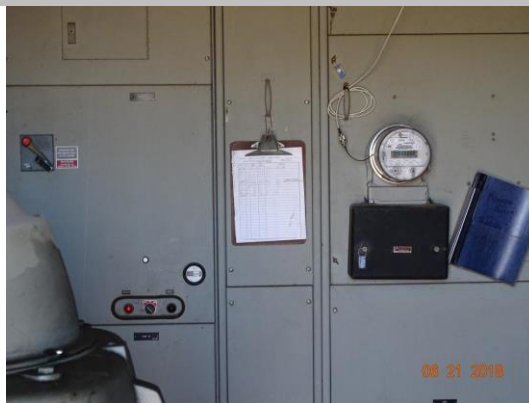
Photo 1 of 1 : ST_2018_NA0017_20_1_20180625_00015.jpg

LM Start	0.00	Rating **	A	Issue No.	1
LM End	0.00	Issue Type +	Ma	Location *	
Category	Pump Stations			GPS Latitude/Longitude	
				Start	End
Item	Operating Log			37.973983 °	37.973983 °
				-121.229967 °	-121.229967 °
DWR ID	DWR_NA0017_20_t_2012_1				
Action/Comments					
Inspector Comments: Maintenance log was present at the pumping plant.

View of the operating log inside the plant.

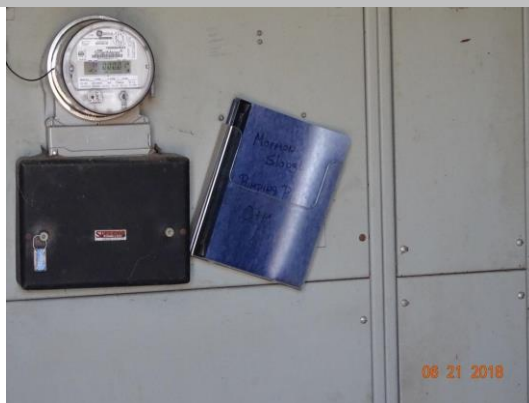
Photo 1 of 1 : ST_2018_NA0017_20_2_20180625_00016.jpg

LM Start	0.00	Rating **	A	Issue No.	2
LM End	0.00	Issue Type +	Ma	Location *	
Category	Pump Stations			GPS Latitude/Longitude	
				Start	End
Item	Operation & Maintenance Manual			37.973983 °	37.973983 °
				-121.229967 °	-121.229967 °
DWR ID	DWR_NA0017_20_t_2012_2				
Action/Comments					
Inspector Comments: The O&M Manual was present at the pumping plant next to the operating log.

View of the O&M manual inside the pumping plant.

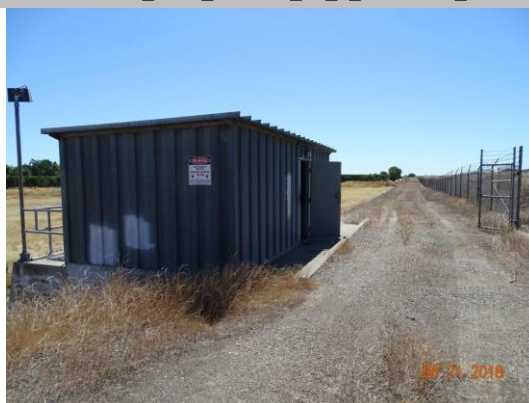
Photo 1 of 1 : ST_2018_NA0017_20_3_20180625_00017.jpg

LM Start	0.00	Rating **	A	Issue No.	3
LM End	0.00	Issue Type +	Ma	Location *	
Category	Pump Stations			GPS Latitude/Longitude	
				Start	End
Item	Plant Building			37.973983 °	37.973983 °
				-121.229967 °	-121.229967 °
DWR ID	DWR_NA0017_20_t_2012_3				
Action/Comments					
Inspector Comments: The plant building appeared to be in good structural condition.

View of the pumping plant.

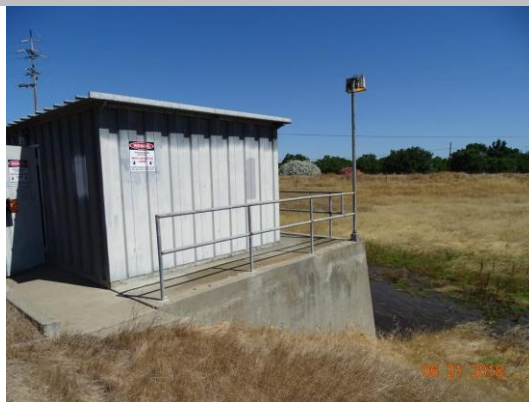
Photo 1 of 1 : ST_2018_NA0017_20_5_20180625_00018.jpg

LM Start	0.00	Rating **	A	Issue No.	5
LM End	0.00	Issue Type +	Ma	Location *	
Category	Pump Stations			GPS Latitude/Longitude	
				Start	End
Item	Safety			37.973983 °	37.973983 °
				-121.229967 °	-121.229967 °
DWR ID	DWR_NA0017_20_t_2012_5				
Action/Comments					
Inspector Comments: No safety hazard was found around the pumping plant and guard rails around the plant were in a good condition.

View of the guard rails around the pumping plant.

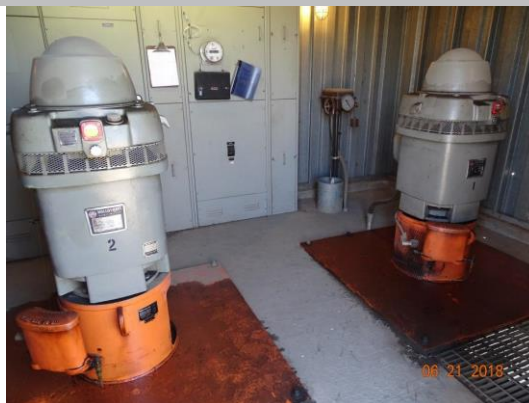
Photo 1 of 2 : ST_2018_NA0017_20_7_20180625_00019.jpg

LM Start	0.00	Rating **	A	Issue No.	7
LM End	0.00	Issue Type +	Ma	Location *	
Category	Pump Stations	GPS Latitude/Longitude			
		Start	End		
Item	Pumps	37.973983 °	37.973983 °		
		-121.229967 °	-121.229967 °		
DWR ID	DWR_NA0017_20_t_2012_7				
Action/Comments					
Inspector Comments: All pumps appeared to be in good condition and maintained properly.

View of the pumps inside the pumping plant.

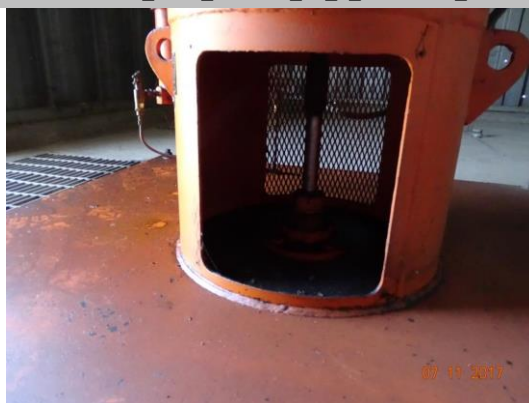
Photo 2 of 2 : ST_2018_NA0017_20_7_20180530_00006.jpg

View of bottom shaft of one of the pumps inside the plant.

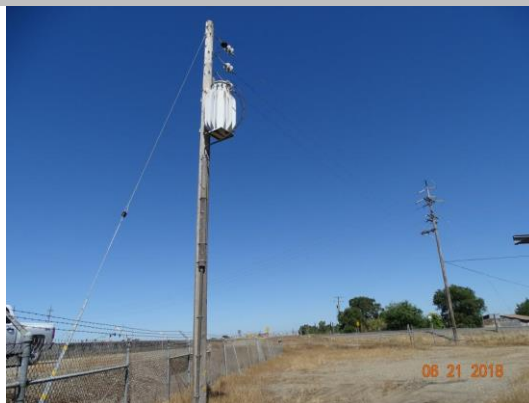
Photo 1 of 1 : ST_2018_NA0017_20_8_20180625_00020.jpg

LM Start	0.00	Rating **	A	Issue No.	8
LM End	0.00	Issue Type +	Ma	Location *	
Category	Pump Stations			GPS Latitude/Longitude	
				Start	End
Item	Power			37.973983 °	37.973983 °
				-121.229967 °	-121.229967 °
DWR ID	DWR_NA0017_20_t_2012_8				
Action/Comments					
Inspector Comments: The power source appeared to be safe and reliable.

View of the power source for the pumping plant.

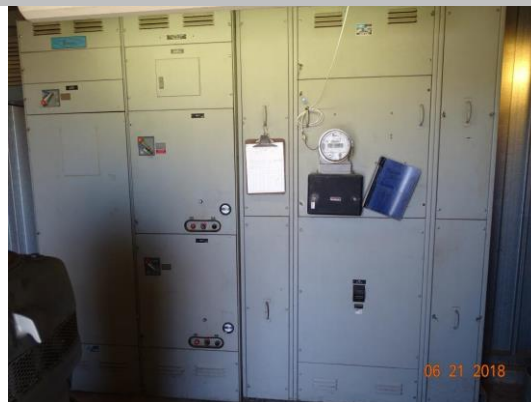
Photo 1 of 1 : ST_2018_NA0017_20_11_20180625_00021.jpg

LM Start	0.00	Rating **	A	Issue No.	11
LM End	0.00	Issue Type +	Ma	Location *	
Category	Pump Stations			GPS Latitude/Longitude	
				Start	End
Item	Pump Control Systems			37.973983 °	37.973983 °
				-121.229967 °	-121.229967 °
DWR ID	DWR_NA0017_20_t_2012_11				
Action/Comments					
Inspector Comments: The pump control system appeared to be operational and free of damage.

View of the power control systems inside the plant.

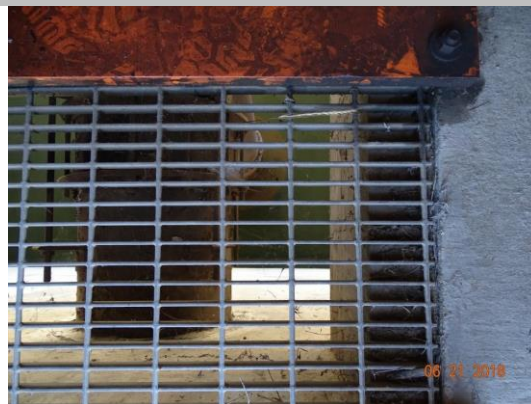
Photo 1 of 1 : ST_2018_NA0017_20_12_20180625_00022.jpg

LM Start	0.00	Rating **	A	Issue No.	12
LM End	0.00	Issue Type +	Ma	Location *	
Category	Pump Stations			GPS Latitude/Longitude	
				Start	End
Item	Sumps/Wet Well			37.973983 °	37.973983 °
				-121.229967 °	-121.229967 °
DWR ID	DWR_NA0017_20_t_2012_12				
Action/Comments					
Inspector Comments: Wet well was clear of any excessive debris.

View of wet well inside the pumping plant.

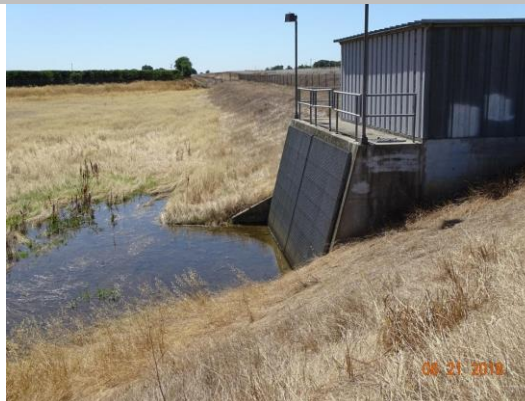
Photo 1 of 1 : ST_2018_NA0017_20_13_20180625_00023.jpg

LM Start	0.00	Rating **	A	Issue No.	13	
LM End	0.00	Issue Type +	Ma	Location *		
Category	Pump Stations			GPS Latitude/Longitude		
				Start		End
Item	Trash Racks			37.973983 °		37.973983 °
				-121.229967 °		-121.229967 °
DWR ID	DWR_NA0017_20_t_2012_13					
Action/Comments						
Inspector Comments: The trash racks were free of any debris.

View of the trash racks.

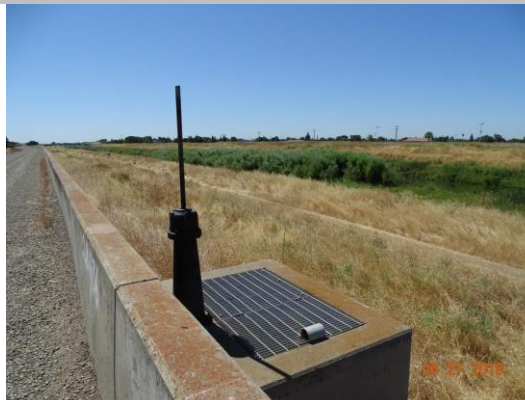
Photo 1 of 1 : ST_2018_NA0017_20_15_20180625_00024.jpg

LM Start	0.00	Rating **	A	Issue No.	15
LM End	0.00	Issue Type +	Ma	Location *	
Category	Pump Stations			GPS Latitude/Longitude	
				Start	End
Item	Sluice / Slide Gates			37.973983 °	37.973983 °
				-121.229967 °	-121.229967 °
DWR ID	DWR_NA0017_20_t_2012_15				
Action/Comments					
Inspector Comments: Slide gates appeared to be free of sediment and obstructions.

View of the slide gate.

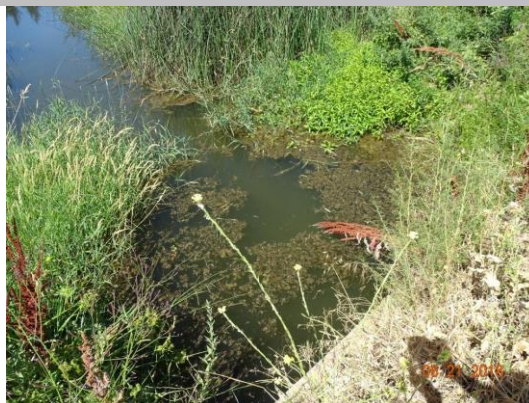
Photo 1 of 1 : ST_2018_NA0017_20_19_20180625_00025.jpg

LM Start	0.00	Rating **	A	Issue No.	19
LM End	0.00	Issue Type +	Ma	Location *	
Category	Pump Stations			GPS Latitude/Longitude	
				Start	End
Item	Flap Gates			37.973983 °	37.973983 °
				-121.229967 °	-121.229967 °
DWR ID	DWR_NA0017_20_t_2012_19				
Action/Comments					
Inspector Comments: Flap gates were not visible during inspection due to water level.

View of the flap gates.

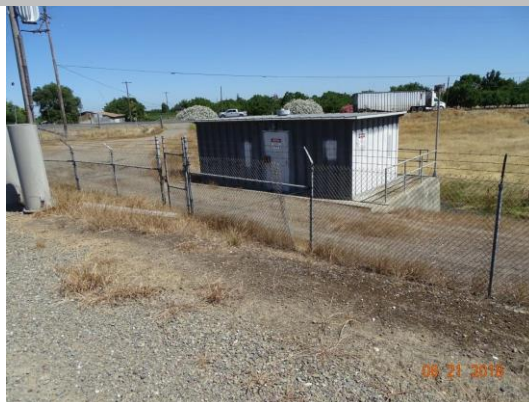
Photo 1 of 1 : ST_2018_NA0017_20_21_20180625_00026.jpg

LM Start	0.00	Rating **	M	Issue No.	21
LM End	0.00	Issue Type +	Ma	Location *	
Category	Pump Stations			GPS Latitude/Longitude	
				Start	End
Item	Security Fencing			37.973983 °	37.973983 °
				-121.229967 °	-121.229967 °
DWR ID	DWR_NA0017_20_t_2012_21				
Action/Comments					
Inspector Comments: Security fencing was damaged in one area near gate and requies repair.

View of the security fencing.
